EXISTING CONDITIONS ANALYSIS

DATA COLLECTION PROCESS

EXISTING CONDITIONS

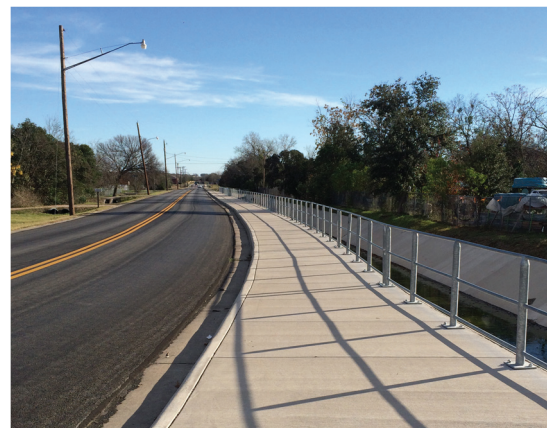
Example of an excellent sidewalk. This sidewalk appears to be in nearly-new condition, is sufficiently wide and has a slope that is level with the adjacent roadway.

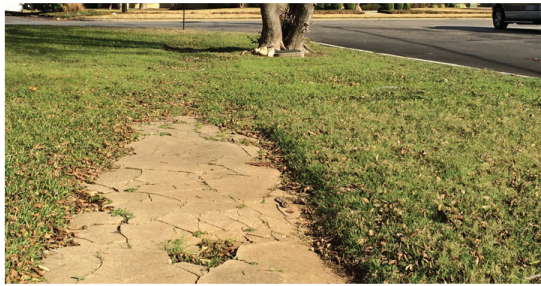
Example of a sidewalk with faulting failure.

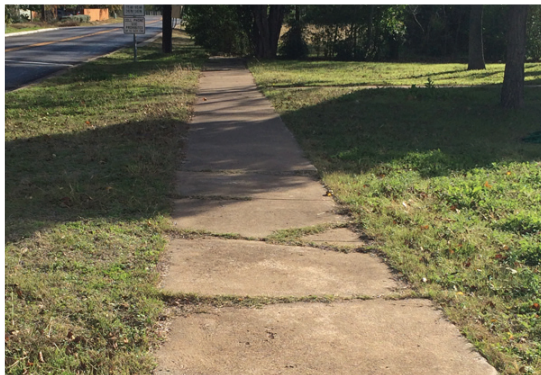
Example of a sidewalk with distortion failure.

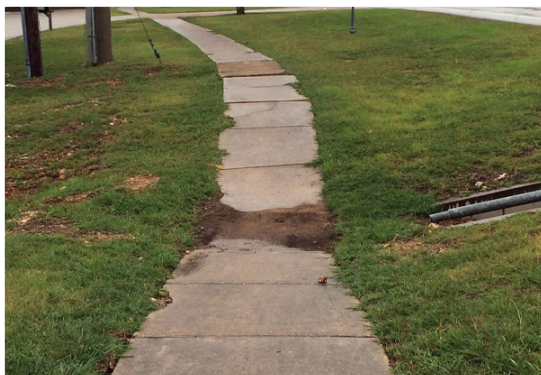
Example of a sunken sidewalk.

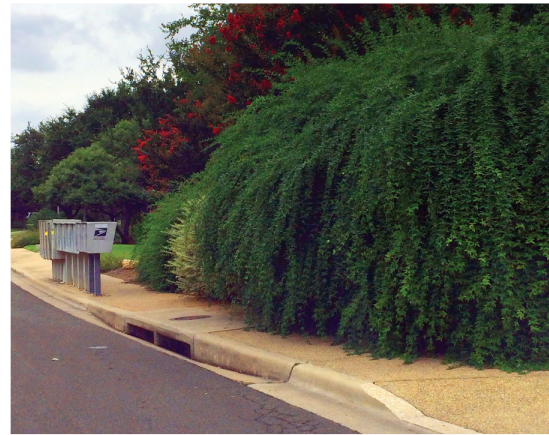
Sidewalks were also inventoried for obstructions in the clear path of the pedestrian facility. An object was considered an obstruction when there appeared to be less than 3' of clearance around the object. Obstructions included, but were not limited to, utility poles, fire hydrants, utility meters, trees, vegetation, signs, benches and trash receptacles.

Vegetation and mailboxes act as obstructions to a clear path on the sidewalk.

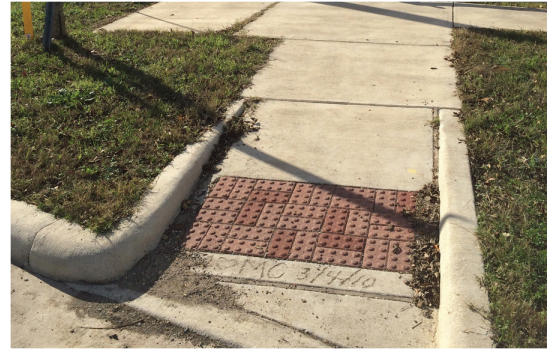
Example of a good curb ramp. The curb ramp provides an adequately-sized landing area, has the appropriate ramp slope and is fitted with a detectable warning surface.

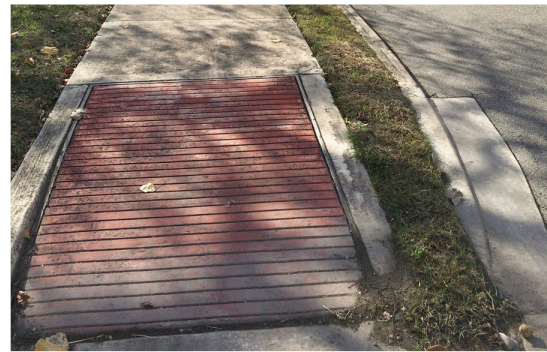
Example of a functional curb ramp. Although the curb ramp provides an adequately sized landing area and has the appropriate ramp slope, the ramp does not have an ADA-compliant detectable warning surface.

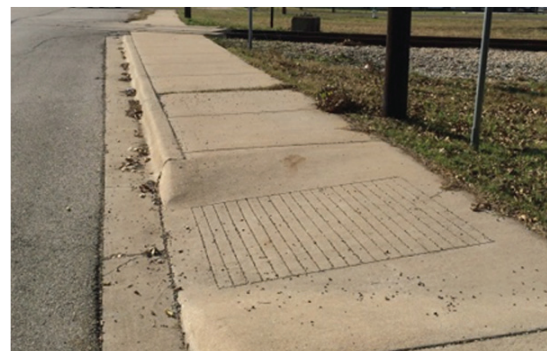
Example of a non-functional curb ramp. The curb ramp does not have a landing area or an ADA-compliant detectable warning surface which makes utilization by a wheelchair extremely difficult.
